**Title:** Assessment of a *Eucalyptus cloeziana*-pole with regard to attack by shipworm

**Report code:** 6.357

**Date:** October 9<sup>th</sup>, 2006

Principal: Wood Solutions B.V.  
Leeuwerikplein 1  
NL-2566 JX THE HAGUE  
Netherlands

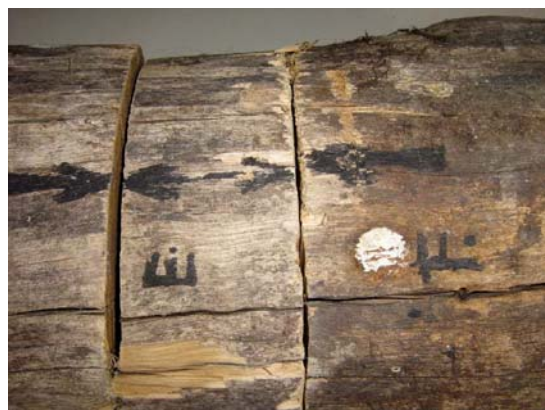
Photo 1 Marks / arrows on the samples E and F

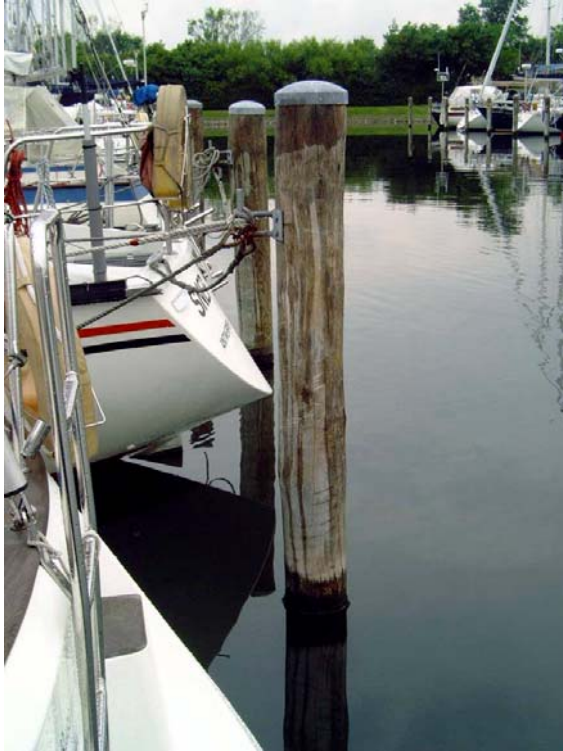
Cloeziana mooring pole in harbour of Herkingen

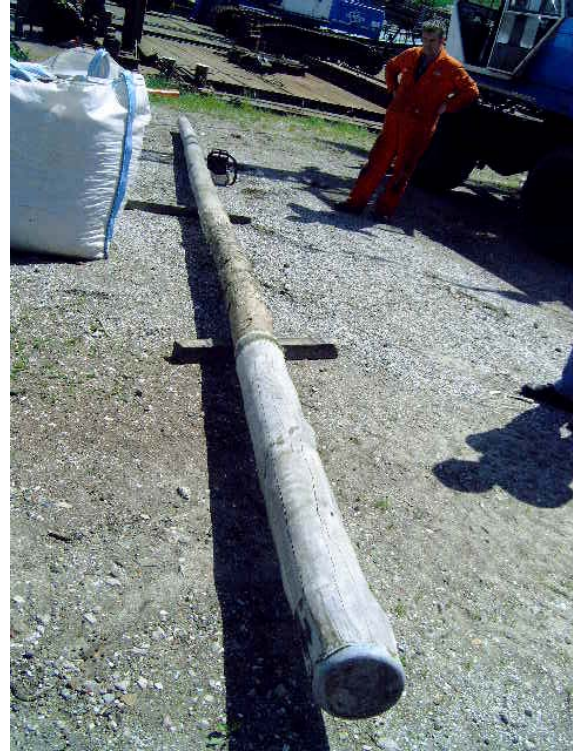
The investigated pole, after being taken out
